CGMS-36, CMA-WP-04
Prepared by CMA
Agenda Item: B.4
Discussed in plenary

FY-2 ANOMALIES AND SPACE WEATHER

FY-2 Anomalies and Space Weather

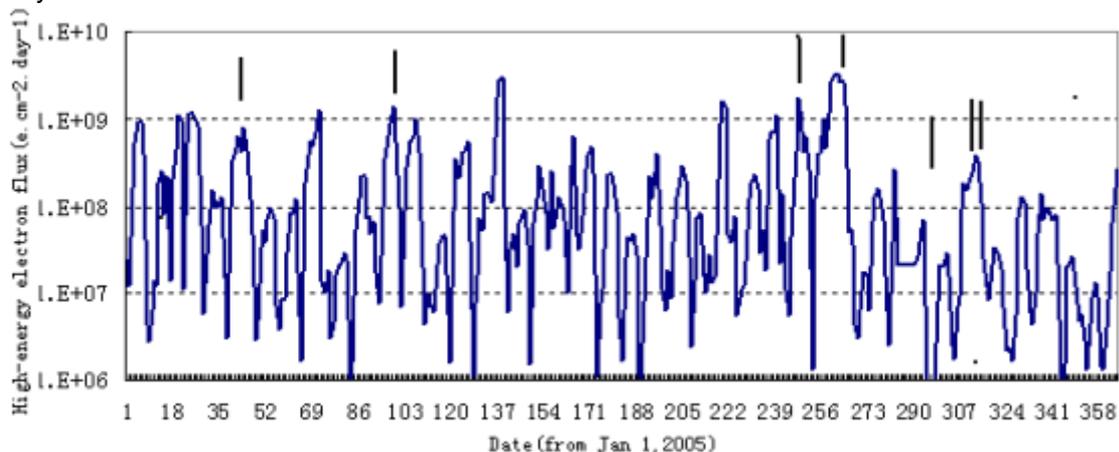
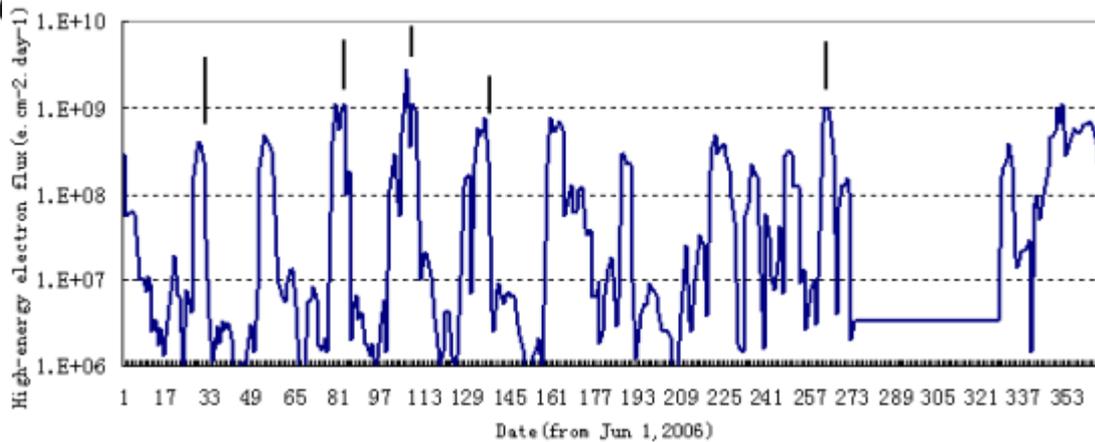
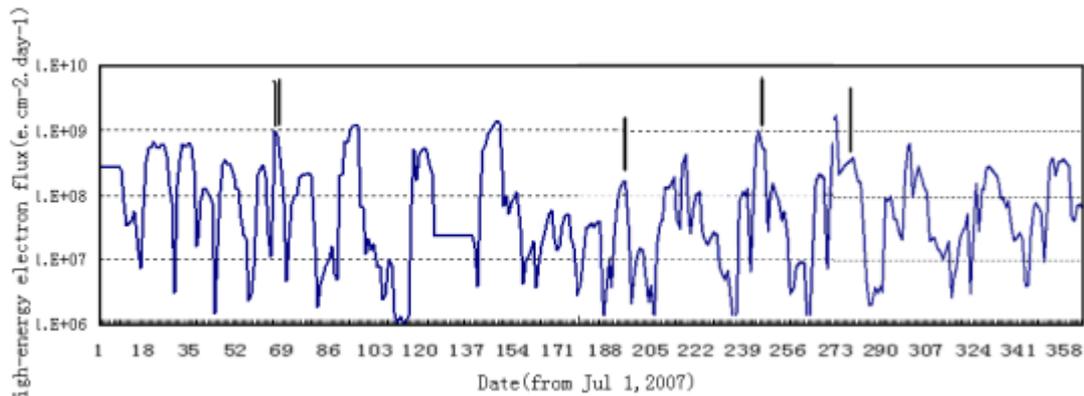
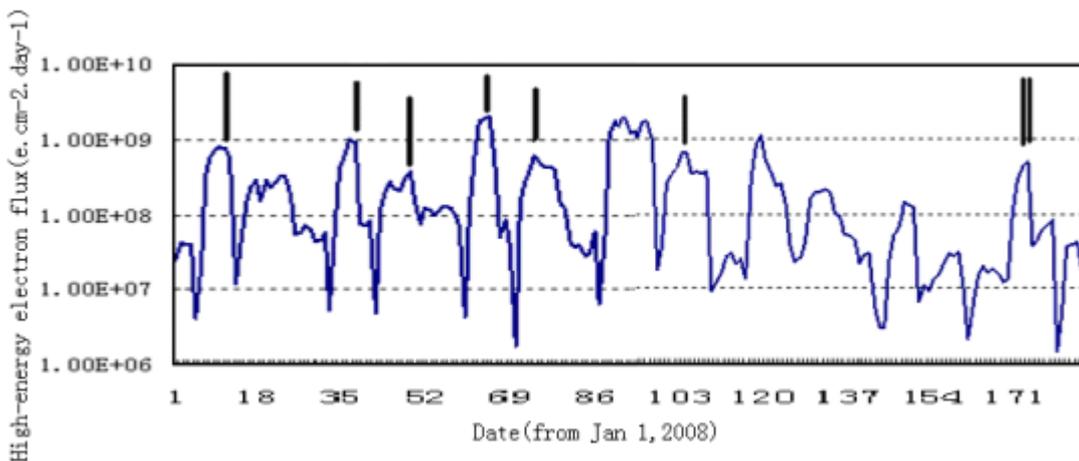
The graphs give the comparison between the jumps of FY-2C and the high-energy electron ($E > 2\text{MeV}$) flux. The upright lines point at the time of jump occurrence.

We find that the jump errors appear at the peak of high-energy electron flux, it must have connection with the deep dielectric charging caused by high energetic electrons.

We only analysed the homologous features of errors on FY-2C with the space weather conditions, the conclusion is preliminary. Further analysis is needed with more historical data of FY-2's errors, and to combine them to develop the effect simulation to make further verification.
